# **Debris/Ice/TPS Assessment and Integrated Photographic Analysis of Shuttle Mission STS-96**

**DEBRIS/ICE/TPS ASSESSMENT  
AND  
INTEGRATED PHOTOGRAPHIC ANALYSIS  
OF  
SHUTTLE MISSION STS-96**

**27 May 1999**

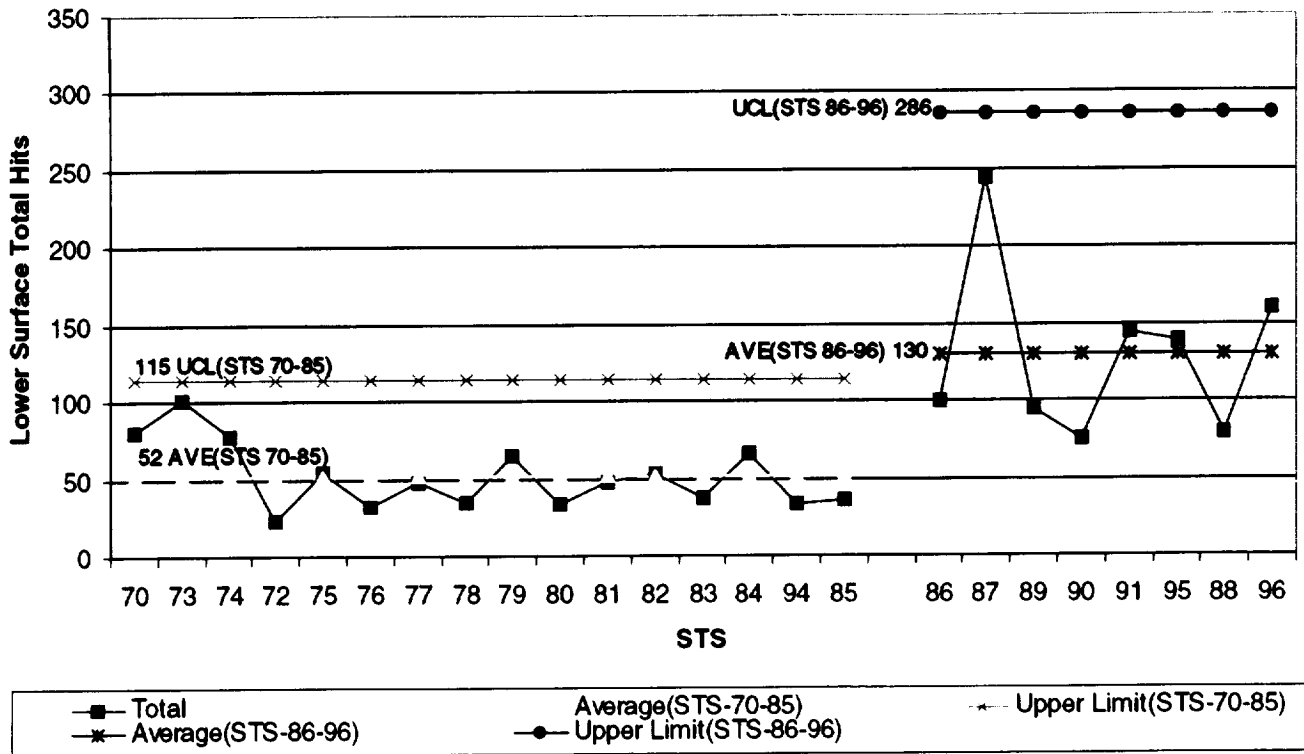
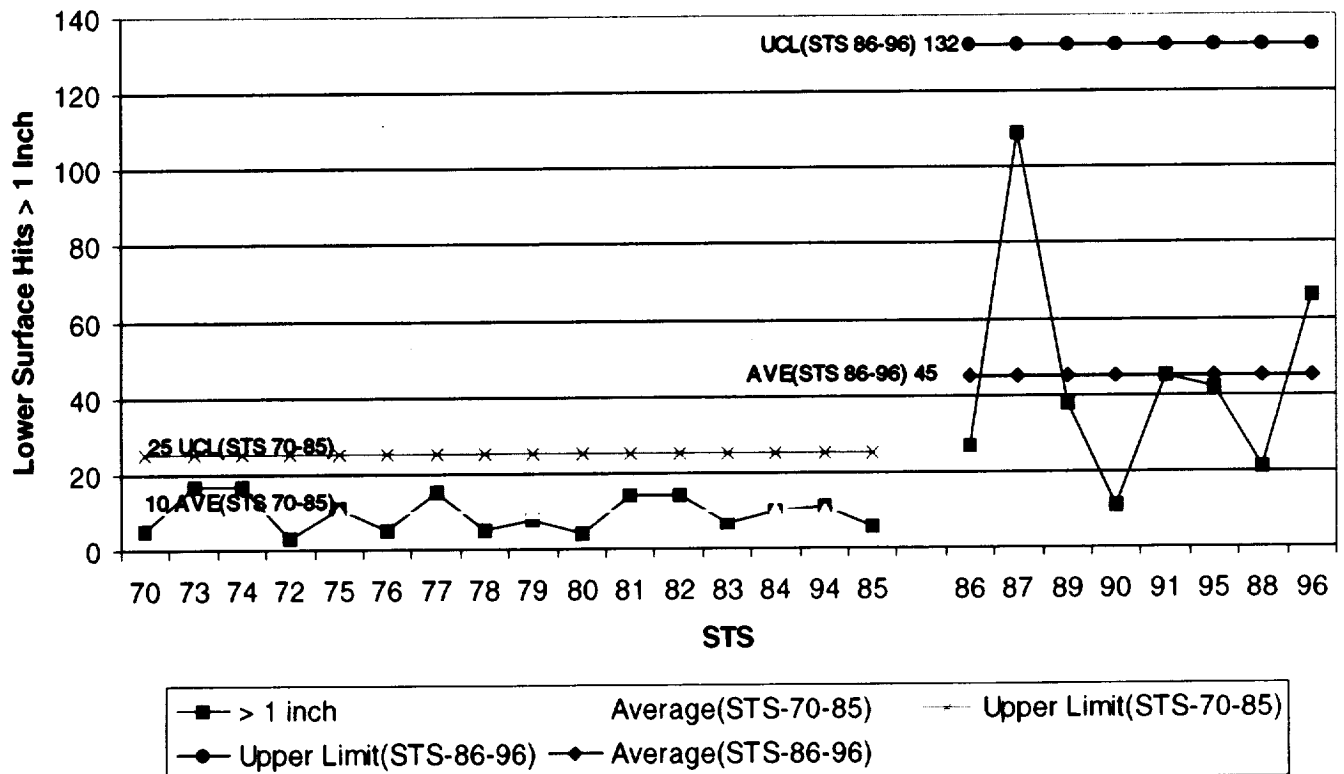
Figure 6: Control Limit Chart for Lower Surface Hits

With data from the last 8 flights showing out-of-family damage to Orbiter tiles, control limit analysis shows a marked change starting with STS-86 (reference Figures 6-7). Data from STS-72 through STS-85 consistently illustrate a relatively low average and reasonable upper control limit. These data represent an environment where the significant debris issues affecting the vehicle had been identified and corrected. However, a few earlier missions were also included to show the downward trend in debris damage representing corrective action still in progress. With the loss of TPS from the External Tank beginning on STS-86, the analysis clearly documents the increase in Orbiter tile damage as an out-of-family condition. Both the average and the upper control limit are significantly higher, and outside the 3-sigma value, for the previous flights.

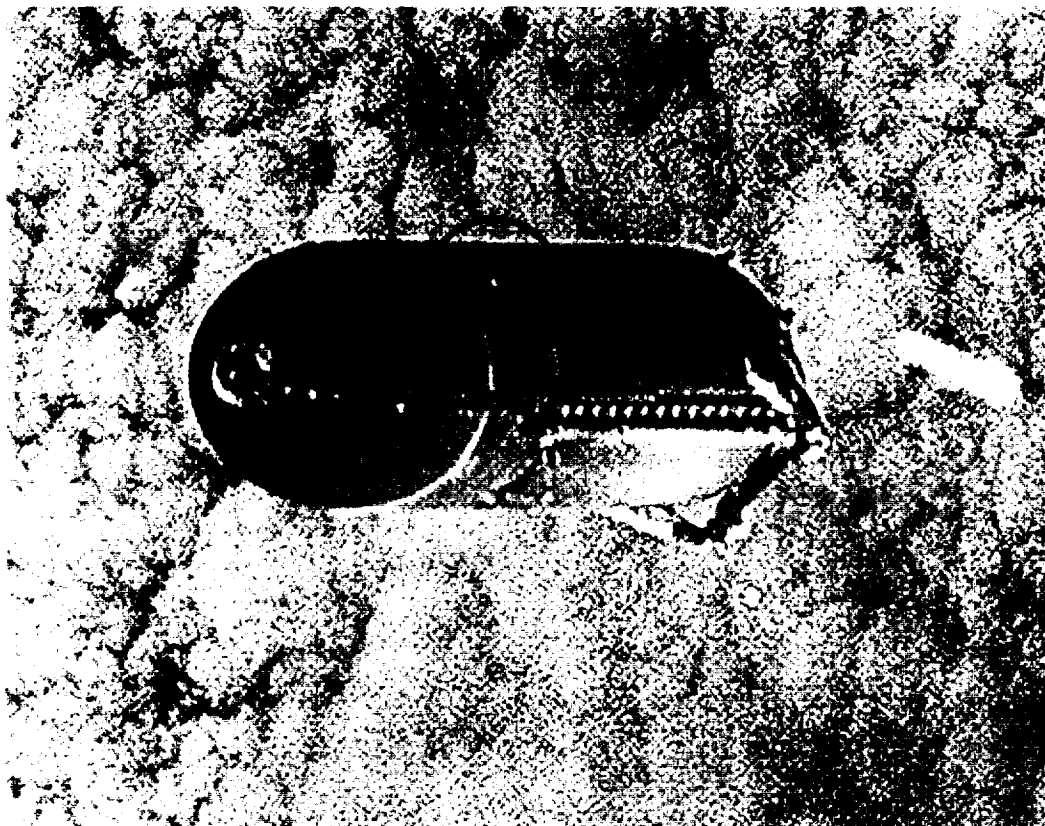
**Figure 2.5.2 (B) + Y Thrust Panel (Frame 1)**

Frame 1 – Several light-colored areas were observed at station 990 in the vicinity of ribs 3 through 7 on the +Y thrust panel. Directly aft of these marks, additional light-colored areas were seen near station 1060. Several light-colored areas were noted inboard from the +Y thrust panel on the intertank TPS between stations 990 and 1100.

Frame 21 – A large, light-colored area was noted on the +Y panel outboard of the RSRB forward attach point between station 890 and 990 in the vicinity of ribs 18 through 25.

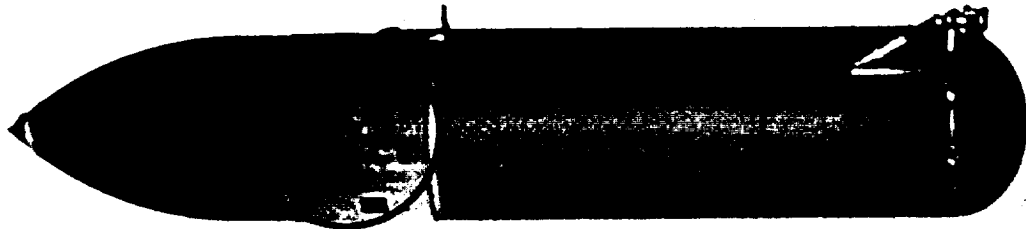
**Figure 2.5.2 (C) -Y Thrust Panel (Frame 15)**

Frame 8 - A significant-appearing light-colored area was seen near the station 990 level in the vicinity of ribs 21 through 26 on the -Y thrust panel. Additional light-colored areas were seen further aft along these same ribs.

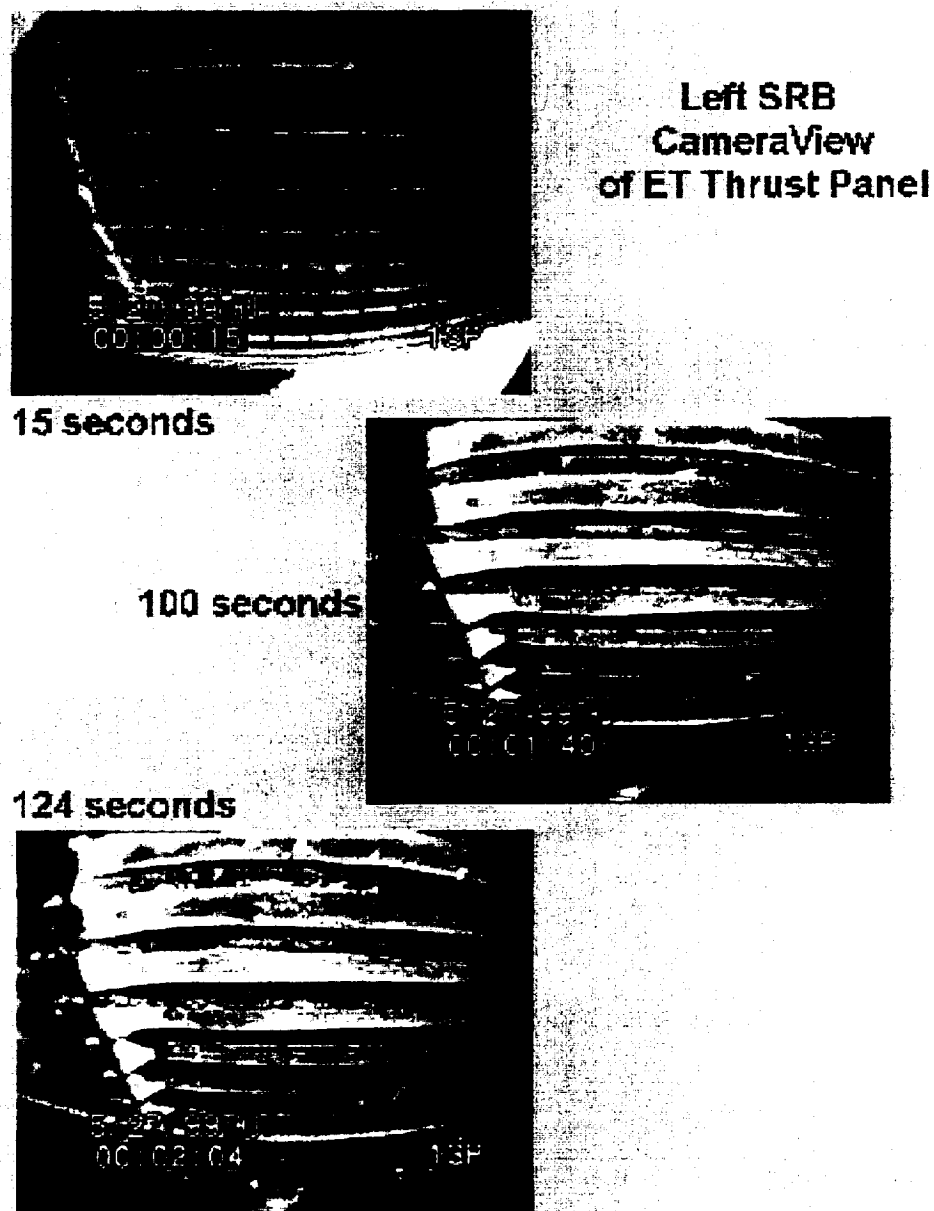
**Figure 2.6 (A) LSRB Views of ET Thrust Panel**

Compared to the equivalent STS-95 mission video of the ET -Y thrust panel, fewer total divots were visible on the STS-96 -Y panel view. Similar to the STS-95 -Y view, the divots occurred on or near the rib heads. Very few divots were noted in the valleys between the ribs. The majority of the divots were near the top of the view in the direction of the SRB forward attach. Several divots were noted outside of the thrust panel on the ET intertank stringers. The divots appeared shallow with no primed substrate visible.

At 22 seconds MET, the first divot was noted (approximately 1/4 inch in size). At 90 seconds, a second divot was noted. By 93 seconds, multiple divots, discoloration and

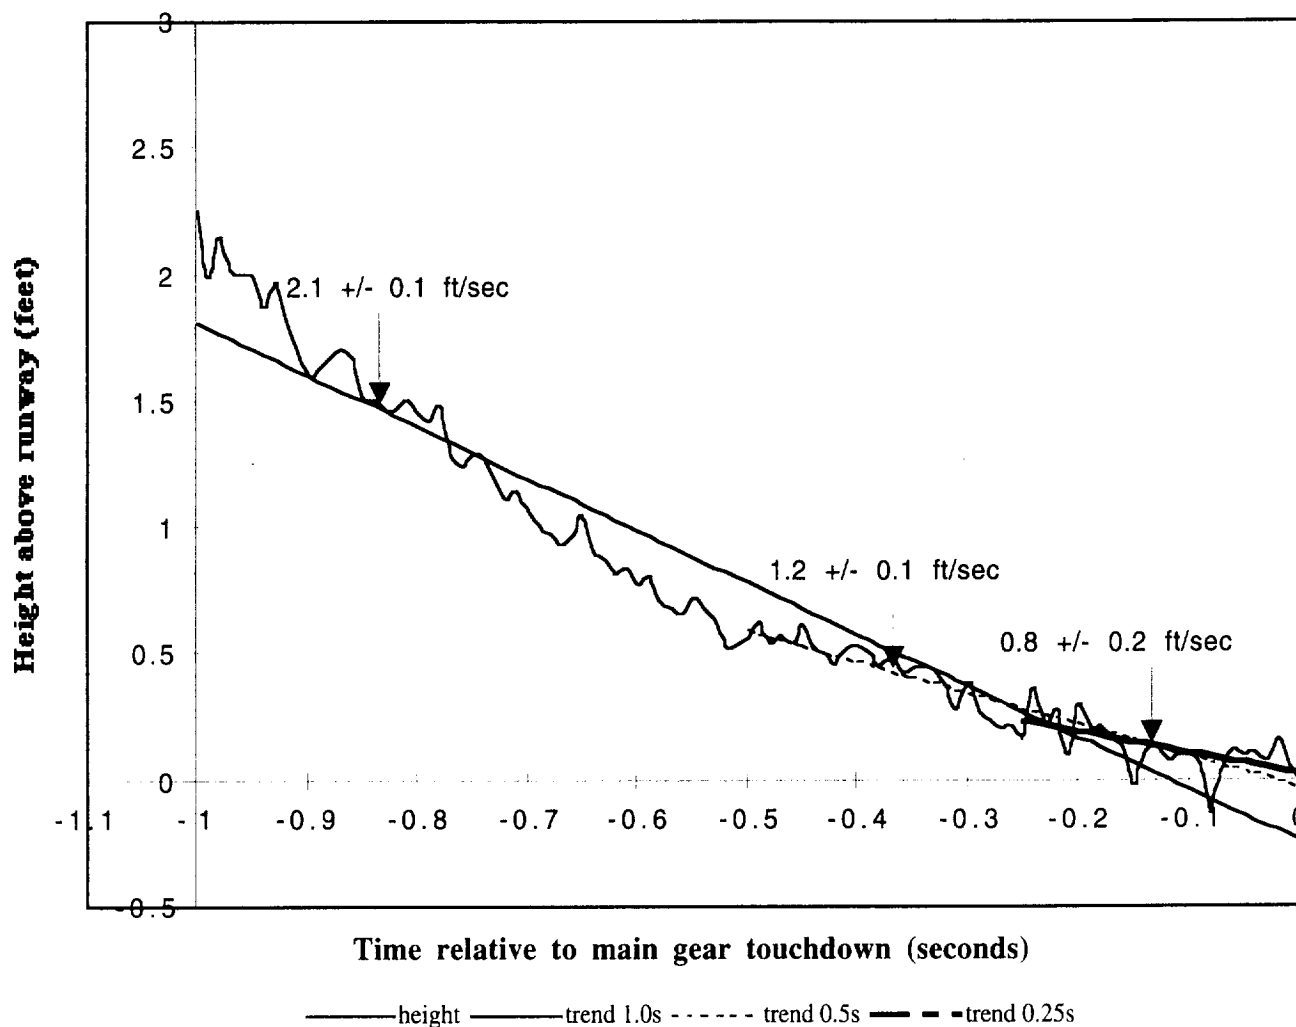
Figure 2.7.1 Main Gear Landing Sink Rate

The maximum allowable main gear sink rate values are 9.6 ft/sec for a 212,000 lb vehicle and 6.0 ft/sec for a 240,000 lb vehicle. The landing weight of the STS-96 vehicle was estimated to be 222,128 lbs.
